**RE: Minor Municipal, SIC 4952, NPDES Compliance Evaluation Inspection, Village of Cimarron Wastewater Treatment Plant, NM0031038, July 7, 2016**

## NPDES Compliance Inspection Report

Village of Cimarron  
NPDES Permit No. NM0031038  
Compliance Evaluation Inspection  
Date of Inspection: July 7, 2016

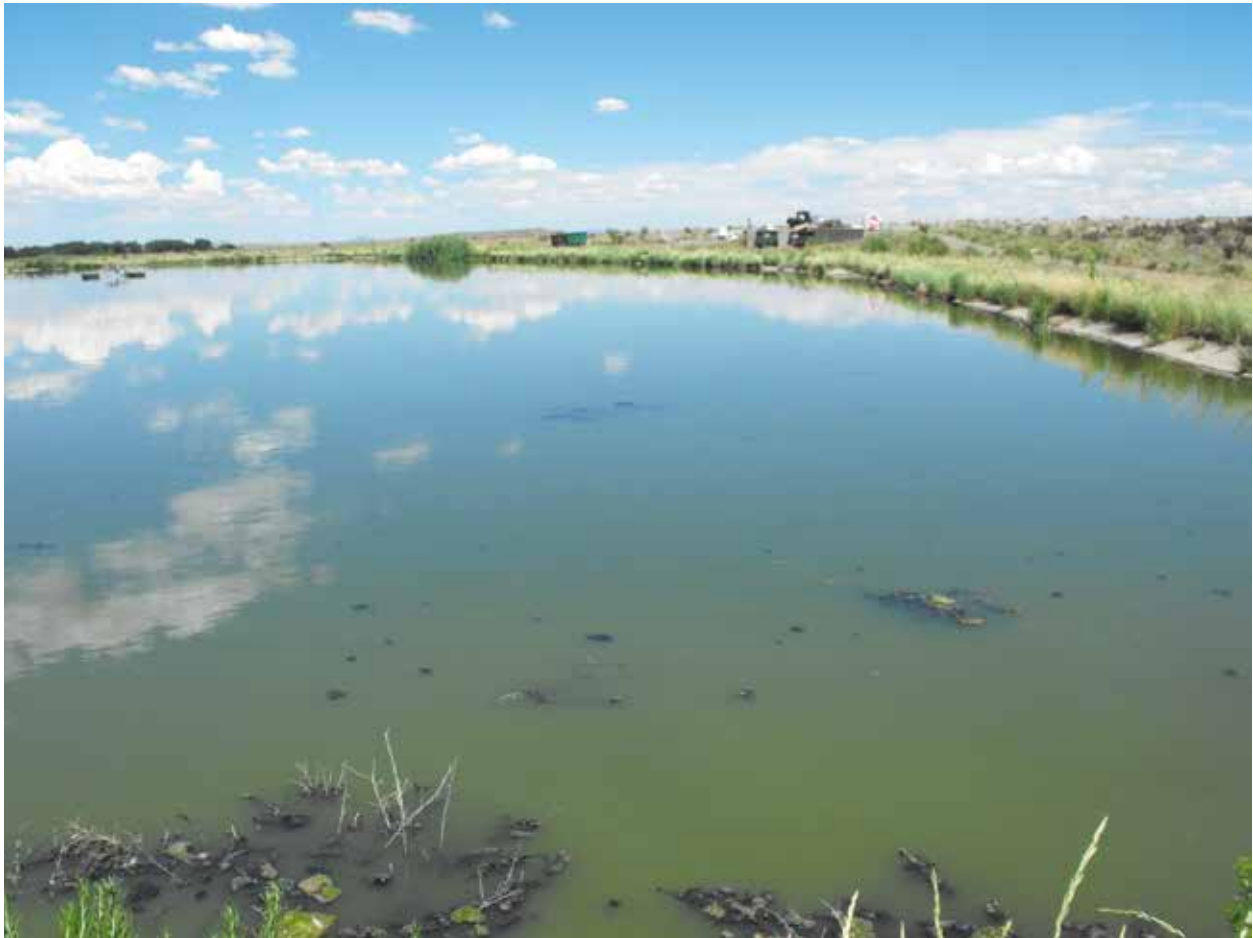
**NMED/SWQB**  
**Official Photograph Log**  
**Photo # 1**

Photographer: Daniel Valenta	Date: July 7, 2016	Time: 1424 Hours
City/County: Village of Cimarron, Colfax County		State: New Mexico
Location: Village of Cimarron Wastewater Treatment Lagoons		
Subject: One of two Lagoons – Floatable solids, indicating advanced age of solids.

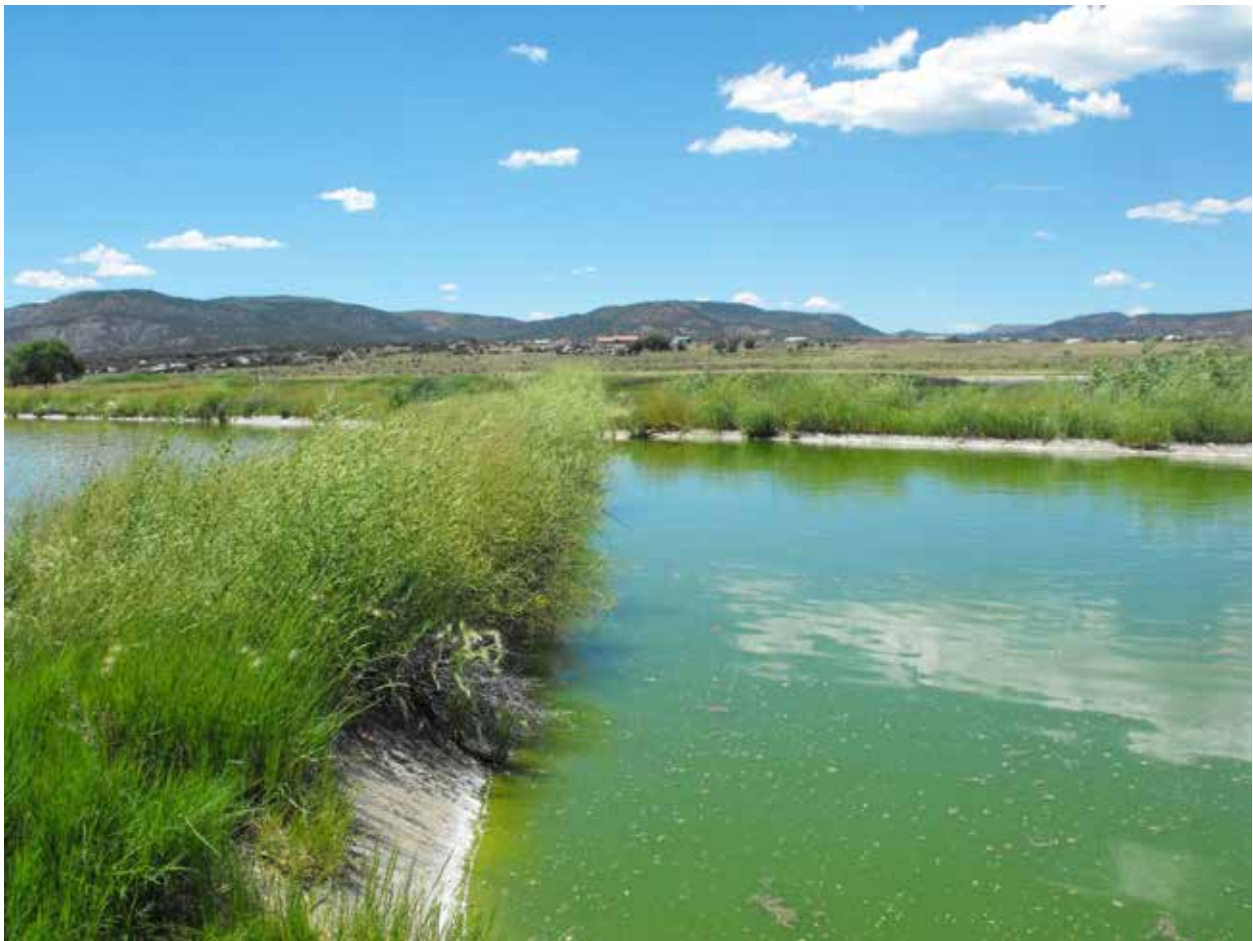
**NMED/SWQB**  
**Official Photograph Log**  
**Photo # 2**

Photographer: Daniel Valenta	Date: July 7, 2016	Time: 1440 Hours
City/County: Village of Cimarron / Colfax County		State: New Mexico
Location: Village of Cimarron Wastewater Treatment Lagoons		
Subject: Overgrown vegetation between the two lagoons

Lagoon banks are covered by vegetation. The lagoons must be kept free of vegetation to prevent liner damage. Trees must not be allowed to grow in either the base or banks of the lagoon. When toured by NMED, the inspectors were unable to observe the outfall due to overgrown vegetation. It is necessary to maintain the lagoons so the operator can capture samples from the discharge point when this facility discharges.

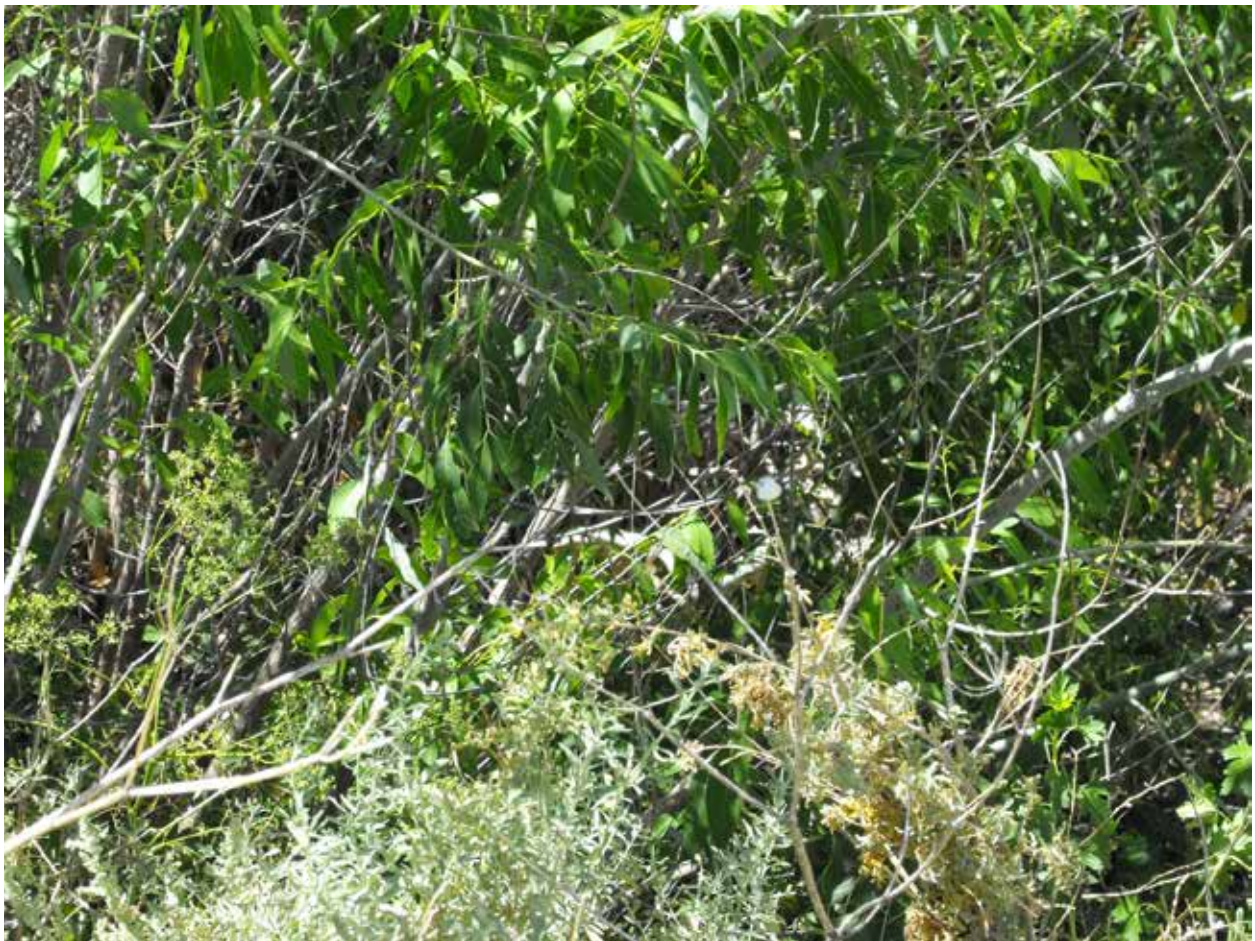
**NMED/SWQB**  
**Official Photograph Log**  
**Photo # 3**

Photographer: Daniel Valenta	Date: July 7, 2016	Time: 1445 Hours
City/County: Village of Cimarron / Colfax County		State: New Mexico
Location: Village of Cimarron Wastewater Treatment Lagoons		
Subject: Discharge outfall – overgrown vegetation – only slightly visible.
